Manhole Inspection Summary

Manhole # S51M__046MH

Insp Date: **4/10/08 3:34 PM**

Location Address: **809 Belnord A**

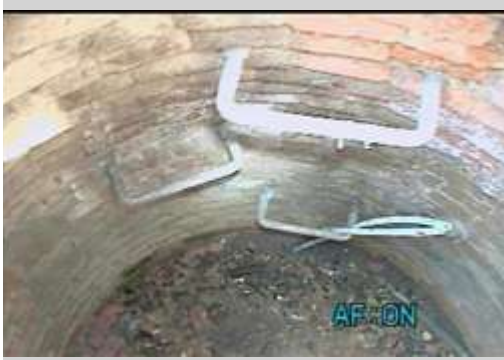
Defect 1

Steps Count: **3** Missing: **0** ☒ **Corroded**

corroded stairs

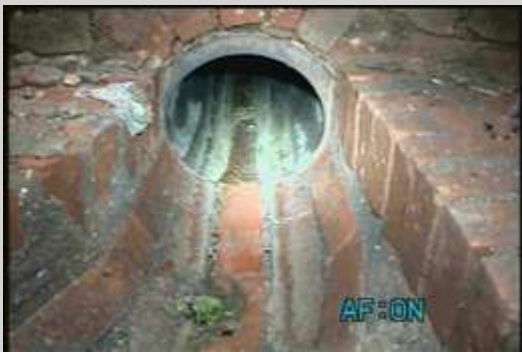
12 O'Clock Outflow

8 in. Circular Gravity Sewer
Pipe Out @ 12 O'Clock

Pipe Material: **Clay** ☐ Pipe Lined

Invert Depth: 7.16 (ft.) Flow Characteristics: **Fast**

Deposits: ☒ None ☐ Mud ☐ Sludge ☐ Debris ☐ Grease

Infiltration: **None** Pipe Seal Cond: **Unknown**

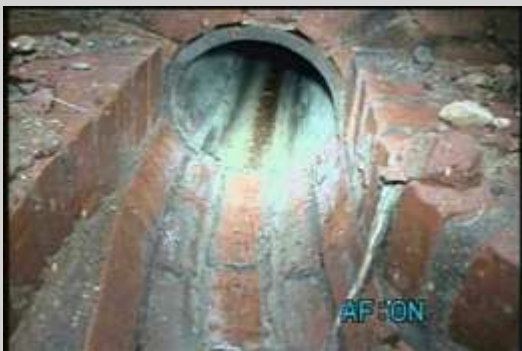
9 O'Clock Inflow

8 in. Circular Gravity Sewer
Pipe In @ 9 O'Clock

Pipe Material: **Clay** ☐ Pipe Lined

Invert Depth: 7.10 (ft.) Flow Characteristics: **Fast**

Deposits: ☒ None ☐ Mud ☐ Sludge ☐ Debris ☐ Grease

Infiltration: **None** Pipe Seal Cond: **Unknown**
